Range Rover
Discovery Series II

PROBLEM:

CLICKING NOISE FROM REAR AXLE

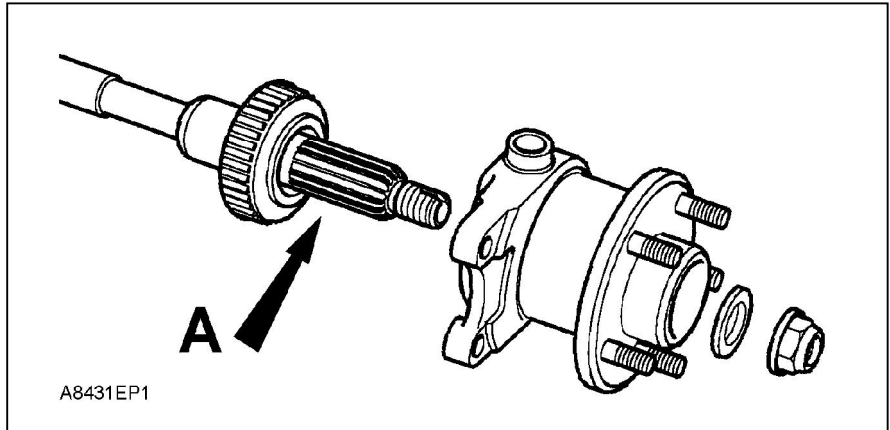
When pulling away from rest in either direction, a clicking noise may be heard from the rear of the vehicle.

Excessive spline movement on either:

- The rear axle shaft to hub spline, (Range Rover).
- The rear differential flange to pinion spline, (Range Rover and Discovery II).

- Carefully remove the hub and shaft assembly from the axle case to avoid damage to the oil seal.
- With axle shaft removed from hub, thoroughly clean and degrease the shaft and flange spline.

- Apply Loctite 648 to the shaft spline ensuring that only the spline area is coated, ('A' in illustration).
- Reassemble the hub and shaft and fit a new stake nut.
- Tighten the stake nut to an initial torque of 100 Nm.
- Carefully refit hub and shaft assembly to axle case avoiding damage to oil seal.

- When the vehicle has been lowered onto road wheels, tighten the stake nut to the full torque of 340 Nm and stake the nut.
- Allow 2 hours for the Loctite to cure before driving vehicle.

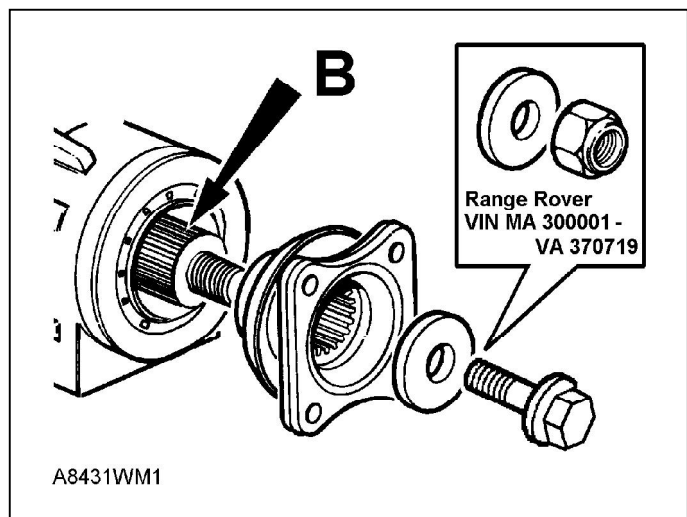
Clicking noise from rear differential flange to pinion spline:

- With pinion flange removed, thoroughly clean and degrease the pinion shaft and flange spline.

- Apply Loctite 648 to the pinion shaft spline ensuring that only the spline area is coated, ('B' in illustration).

CAUTION: Range Rover vehicles up to 97.5 Model Year - VIN VA 370719 - have pinion flanges secured with a nut. Later vehicles use a flange bolt, (refer to illustration). It is essential that each fixing type is tightened to the correct torque as specified below.
